### CONFEDERACIÓN HIDROGRÁFICA EBRO

# Water-ForCE Proyect Copernicus applications at CHE

## Ebro River Basin Authority as a Copernicus user

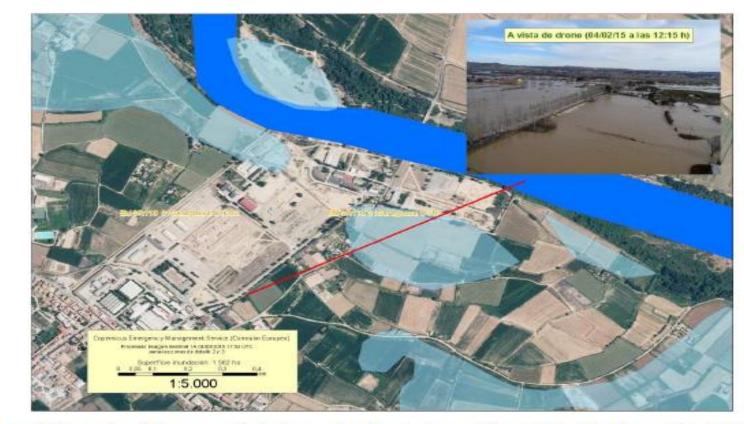
Figure 8. Example of discrepancies between the flooded area delineated by the Copernicus-EMS map (transparent light blue areas) and the ground-truth data taken from a drone (oblique photography in the upper right corner of the map). Source: Confederación Hidrográfica del Ebro (CHE).

According to data provided by the CHE, the flood peak arrived Zaragoza city on 04/02/2015 around 04:00 local time (03:00 UTC). Thus, both, Sentinel 1A image and the aerial photography taken from the drone correspond to images after the flood peak. Considering that the Sentinel 1A image was acquired almost seven hours after the oblique photo, it could be deduced that water was disappeared from the surface in that time. However, rest of flooding is not seen in the area when watching the satellite image.

Some differences were found between the flooded area layer of a product of the Copernicus-EMS Mapping service (P8) and the one created by the EMS-Validation service. It is believed that these discordances can be due to the use of different polarization of the radar (Sentinel-1A) image.

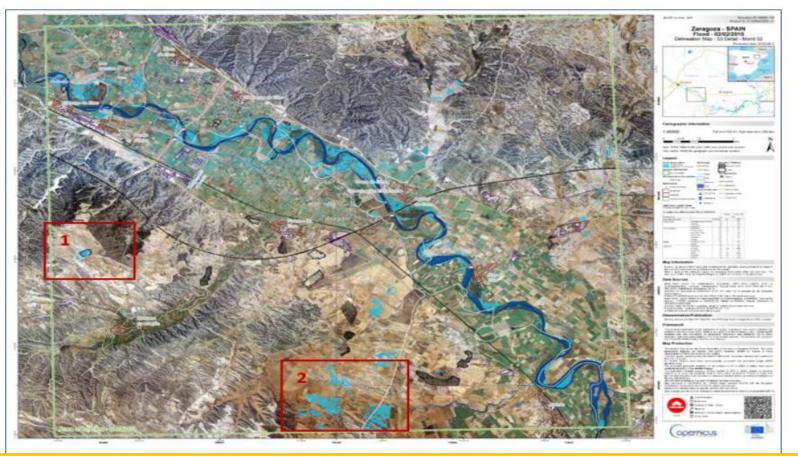
Interview template for Users EMSV014. Valuation of EMSR120 Some areas identified as "flooded areas" in the Copernicus-EMS maps are not real flooded areas. As it is shown in Figure 5 some areas identified as "flooded areas" in the Copernicus-EMS are not real flooded areas; some of them are far away from the river.

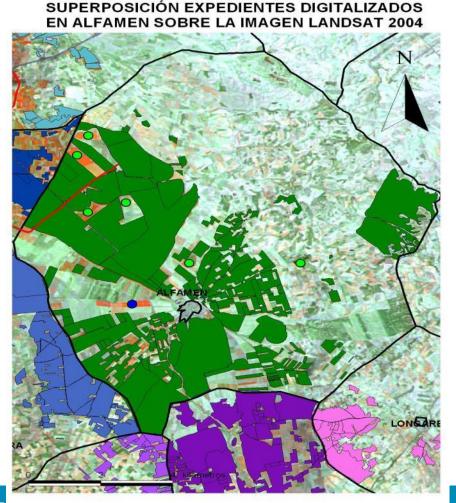
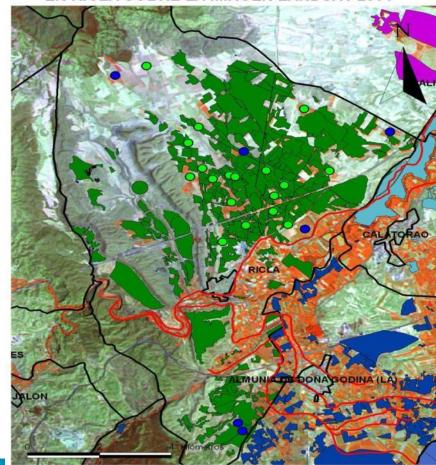
SUPERPOSICIÓN EXPEDIENTES DIGITALIZADOS EN RICLA SOBRE LA IMAGEN LANDSAT 2004

#### Check: comparison of groundwater harvesting files with the 2004 Landsat image

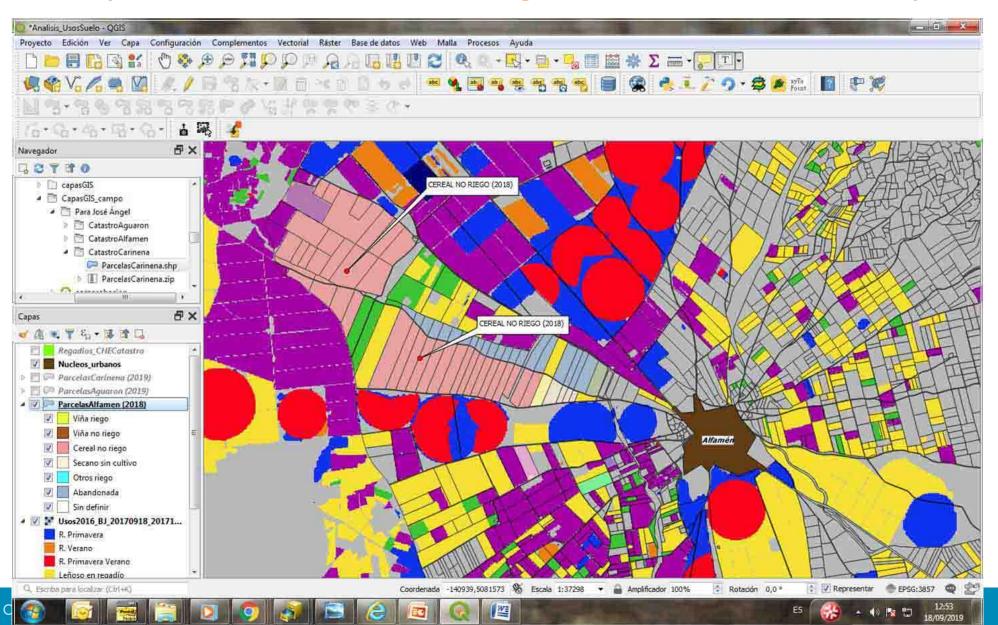
GIS analysis results validation: uses of the ground in 2016 versus Cadastral plots with "ground truth"

It is observed how the non-irrigated plots according to Diana H2020 correspond to non-irrigated plots verified in the field

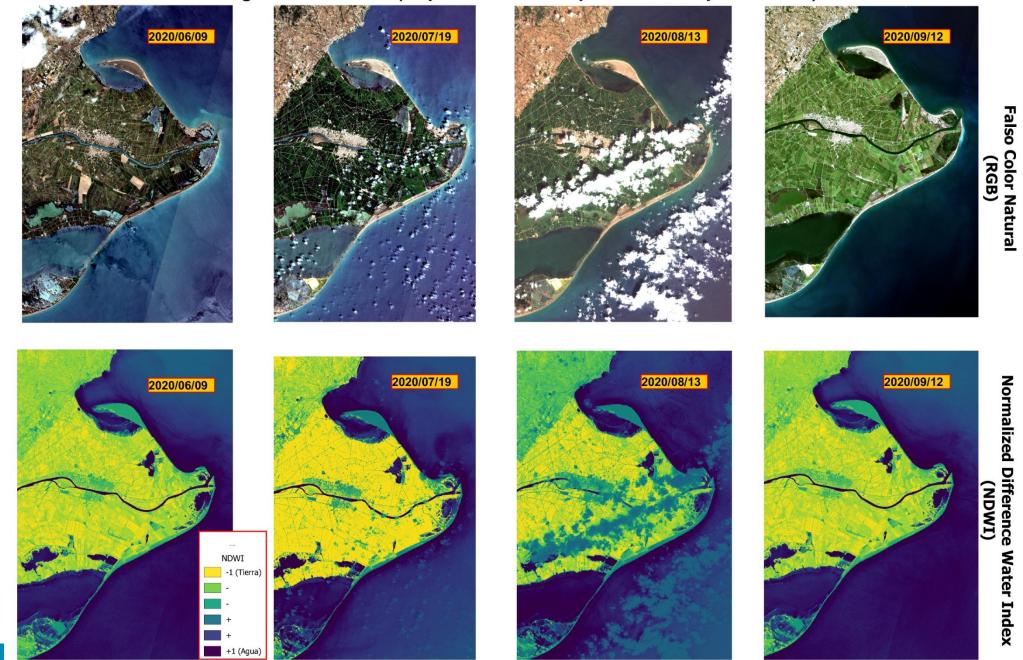
#### Imágenes Sentinel-2 (Copernicus Hub https://scihub.copernicus.eu)

Water Index

>An RGB image of the Ebro Delta (10 m spatial resolution).

>An NDWI ("Normalized Difference Water Index") image of the Ebro Delta (10 m spatial resolution).

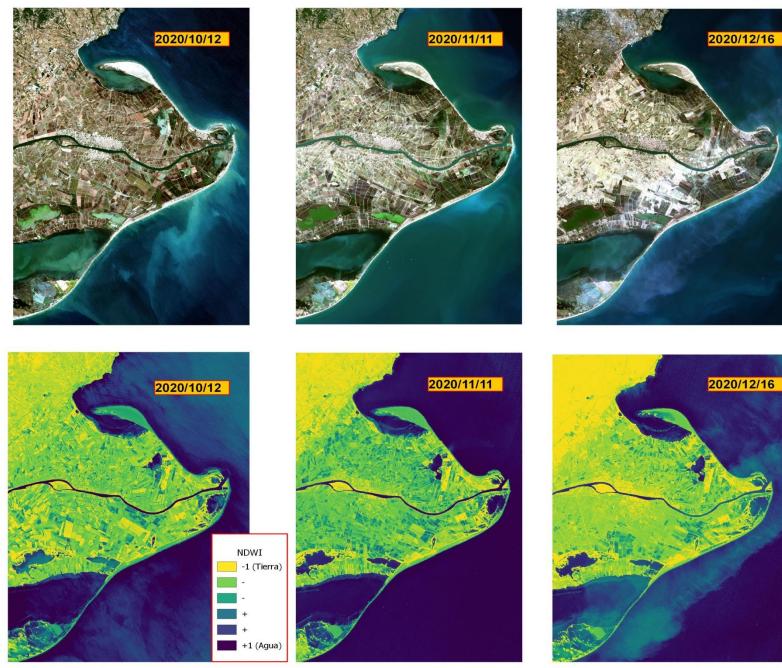
Normalized Difference Water Index (NDWI)

#### Imágenes Sentinel-2 (Copernicus Hub https://scihub.copernicus.eu)

This facilitates the spatial and temporal monitoring (on an monthly scale) in relation the presence of water in the Ebro delta and its coastal arrows.
